Seismic Testing of RC Concrete Squat Wall with Opening w/o Octaform system Vancouver, BC

Prepared for: Octaform Concrete Forming Systems Vancouver, BC

Prepared By:
Jose Centeno
Devin Sauer
Felix Yao, P. Eng
Dr. Carlos E. Ventura, P.Eng

> July 2007 EERF 07-07

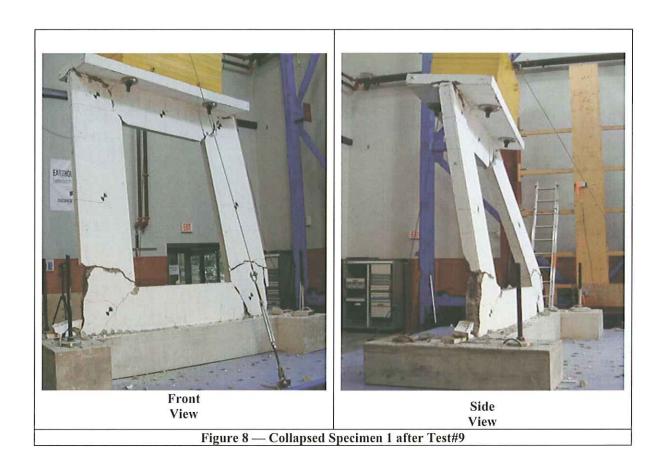
The collapse occurred during the second VERTEQII 200% record, when a crack developed due to a combination of flexure and shear at the bottom of the clear length of

the left column; consequently, allowing significant rotation. When the subsequent spalling of the concrete cover occurred, this column became unstable and the specimen collapsed out of plane (see Figure 8).

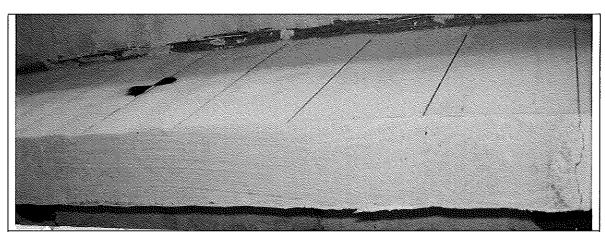
Figure 10— Hairline flexural crack at the right corner of the beam after VERTEOII-250%

When the consecutive test was done (VERTEQ-II 250%), the diagonal crack previously observed opened up and increased in length. Also, a hairline flexural crack was formed on the right corner of the beam (Figure 10). No more additional increases in amplitude for the record were performed and position transducers were disconnected.

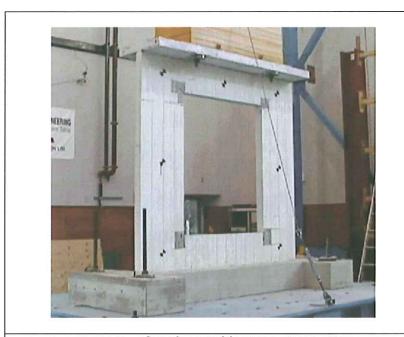
Figure 11— Specimen with OCFS after test#10.

The final tests done on the specimen included four sequences of VERTEQ-II records with 30 second waiting time between records. Incorporated within these sequences were: two VERTEQ-II 100%, three VERTEQ-II 200%, three VERTEQ-II 225% and three VERTEQ-II 250%. These tests produced no additional cracks; however, existing cracks became wider and longer. No additional dynamic tests were performed (Figure 11).

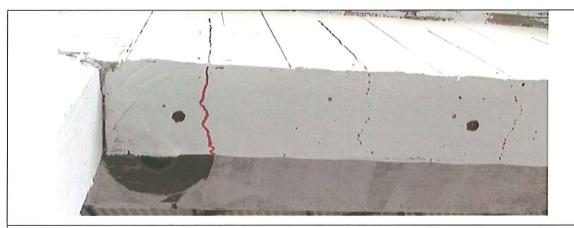
Figure 12 — Flexural cracks observed along span of beam coinciding with center line of each OCFS panel.

At the end of testing, specimen 2 showed a minimal amount of diagonal cracks at the corners of the opening and significant flexural cracks at the ends of the beam. All flexural cracks observed along the span of the beam coincided with the location of the center line of each OCFS panel (see Figure 12).

Flexural cracks formed along the span of the beam for both specimens although, the location of cracks significantly differed. For specimen 1, the flexural cracks coincided with the location of the vertical reinforcement. For specimen 2, the flexural cracks mostly coincided with the location of the center line of each OCFS panel. The widths of the cracks in the beam of specimen 2 were smaller than the corresponding cracks observed in specimen 1.
