UNIVERSITY
OF MANITOBA

INNOVATIVE DESIGN FOR MANURE STORAGE FACILITIES

Final Report

June 2002

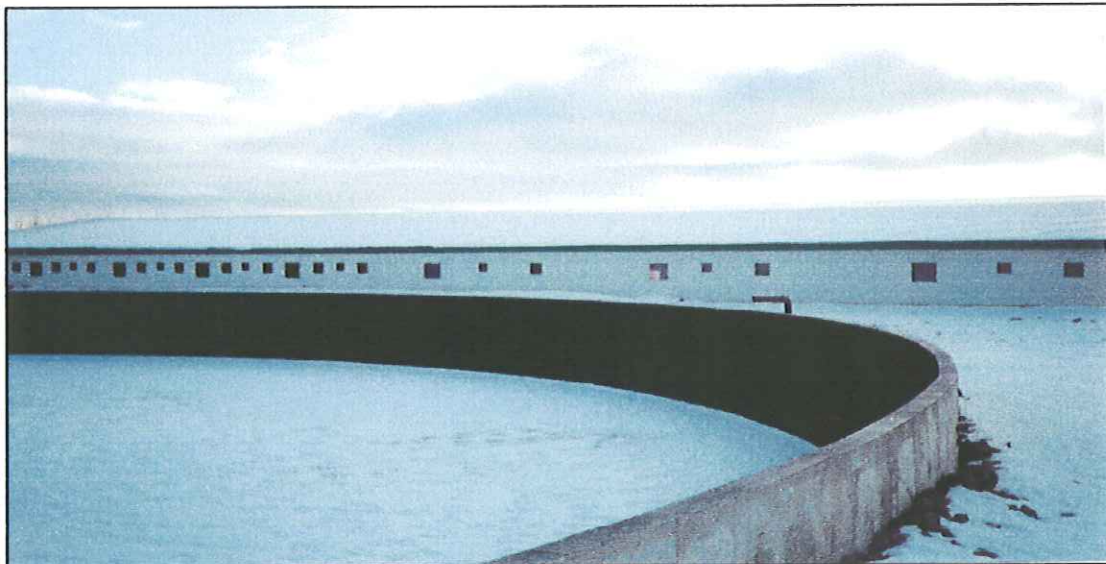
Figure 3.2. Typical cast-in-place reinforced concrete tank (built by DGH Engineering Ltd.).

The backfill consists of compacted material and it is used as structural support for the wall. In addition, the backfill provides protection for the footing from frost. To prevent any possible water pressure if the tank is emptied during periods of high watertable, drainage is ensured by a granular fill base for the floor, and a perimeter drainage system.

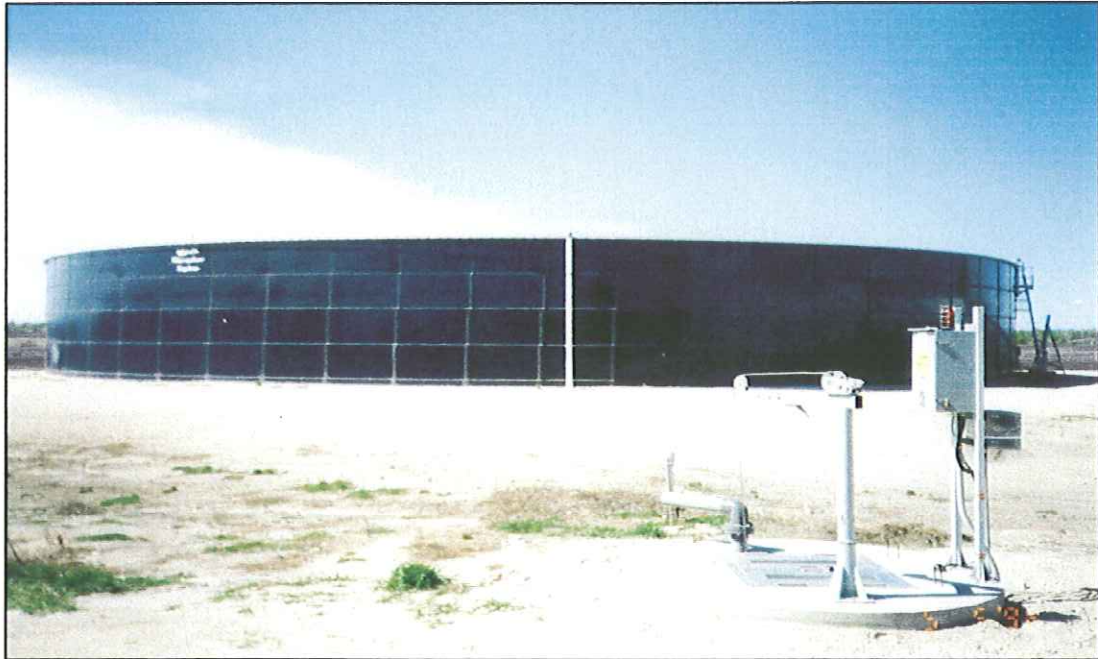
Figure 3.3. Typical steel tank (Slurrystore systems, built by Mannagro Harvestore).

Steel tank - Steel tanks are common in Europe but they have not been used extensively in North America. The common brand name available on the market in Canada is "Slurrystore systems" build by authorized dealers of A.O. Smith Harvestore. There are 21 tank models of various diameters and heights with capacities from 140 to 2.3 million gallons. A typical steel tank is presented in Figure 3.3.

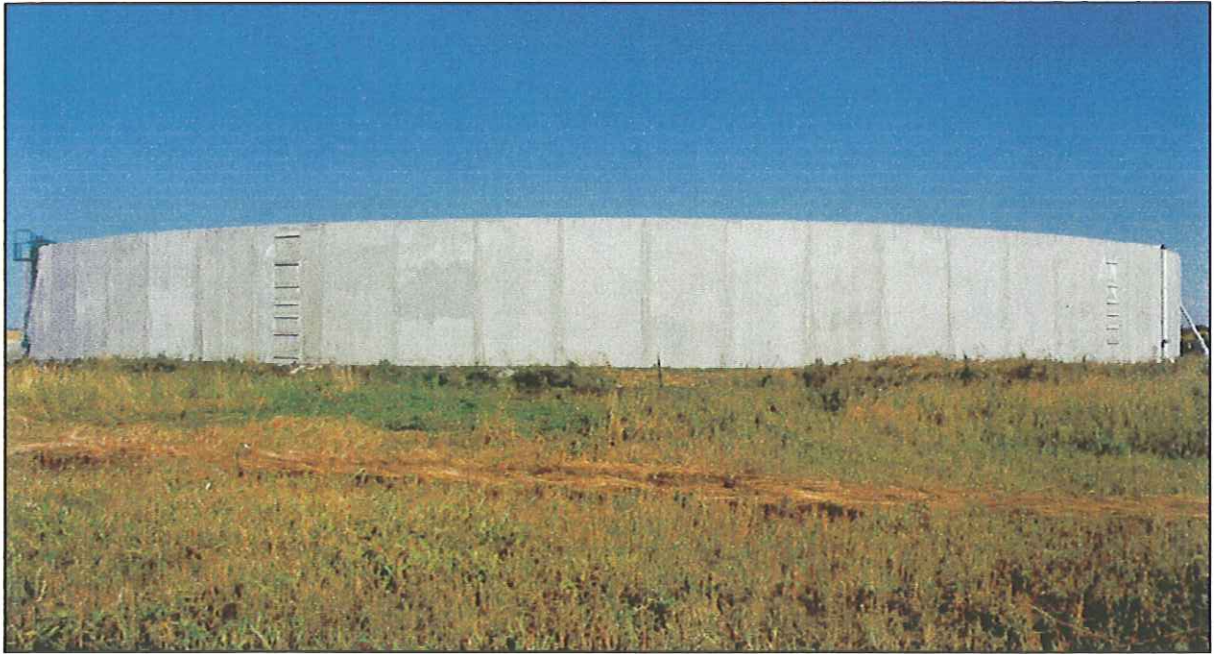
Figure 3.4. Typical precast reinforced concrete tank (built by Con-Force Structure Ltd.).

wall panels and grouted joints. Large capacity tanks with heights between 7.62 and 8.84 m, are generally built with precast panels. For example, a recent 8.0 million gallon tank was built at Waldheim Colony Marquette, in Manitoba. A typical precast reinforced concrete tank is shown in Figure 4.

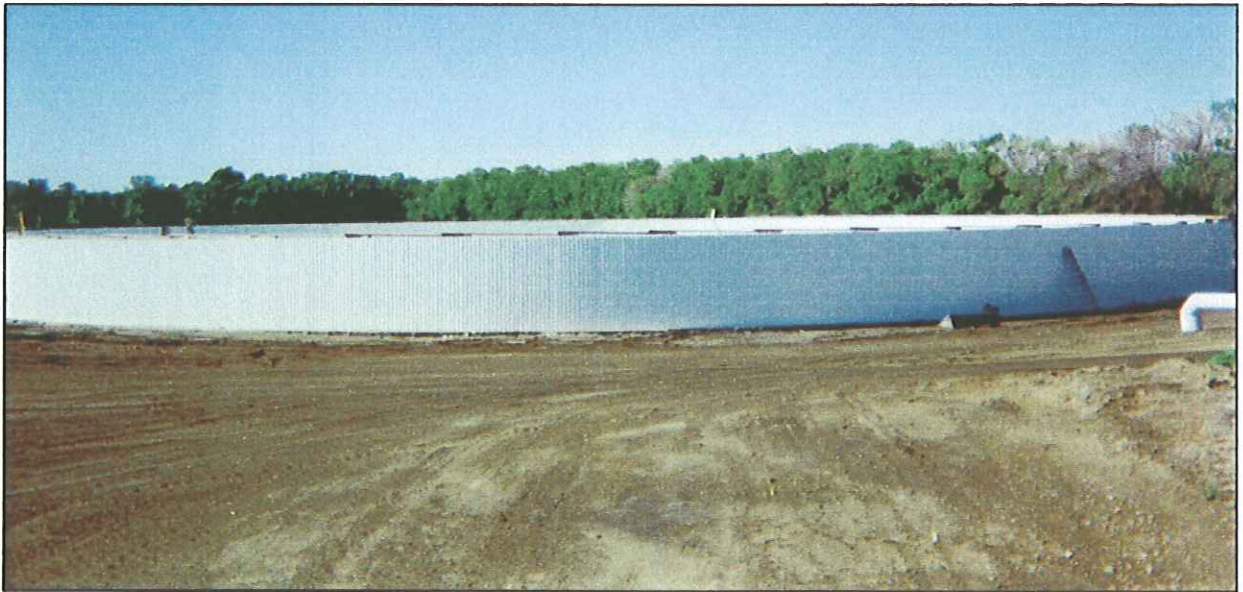
Figure 3.5. Typical cast-in-place OCTAFORM reinforced concrete tank (built by Excel / Samson Engineering Services).

Cast-in-place, OCTAFORM (PVC) reinforced concrete tank - Essentially, this design is very similar to the standard cast-in-place design presented above. The difference is that the casting forms for this design are PVC panels of a special profile and joining system (known as the OCTAFORM system) which remain in place after the concrete is cast. The height of the panel is 4.877 m. Since the thickness of the wall is variable, tanks of various capacities can be built by adjusting the diameter. A typical cast-in-place OCTAFORM reinforced concrete tank is presented in Figure 5.

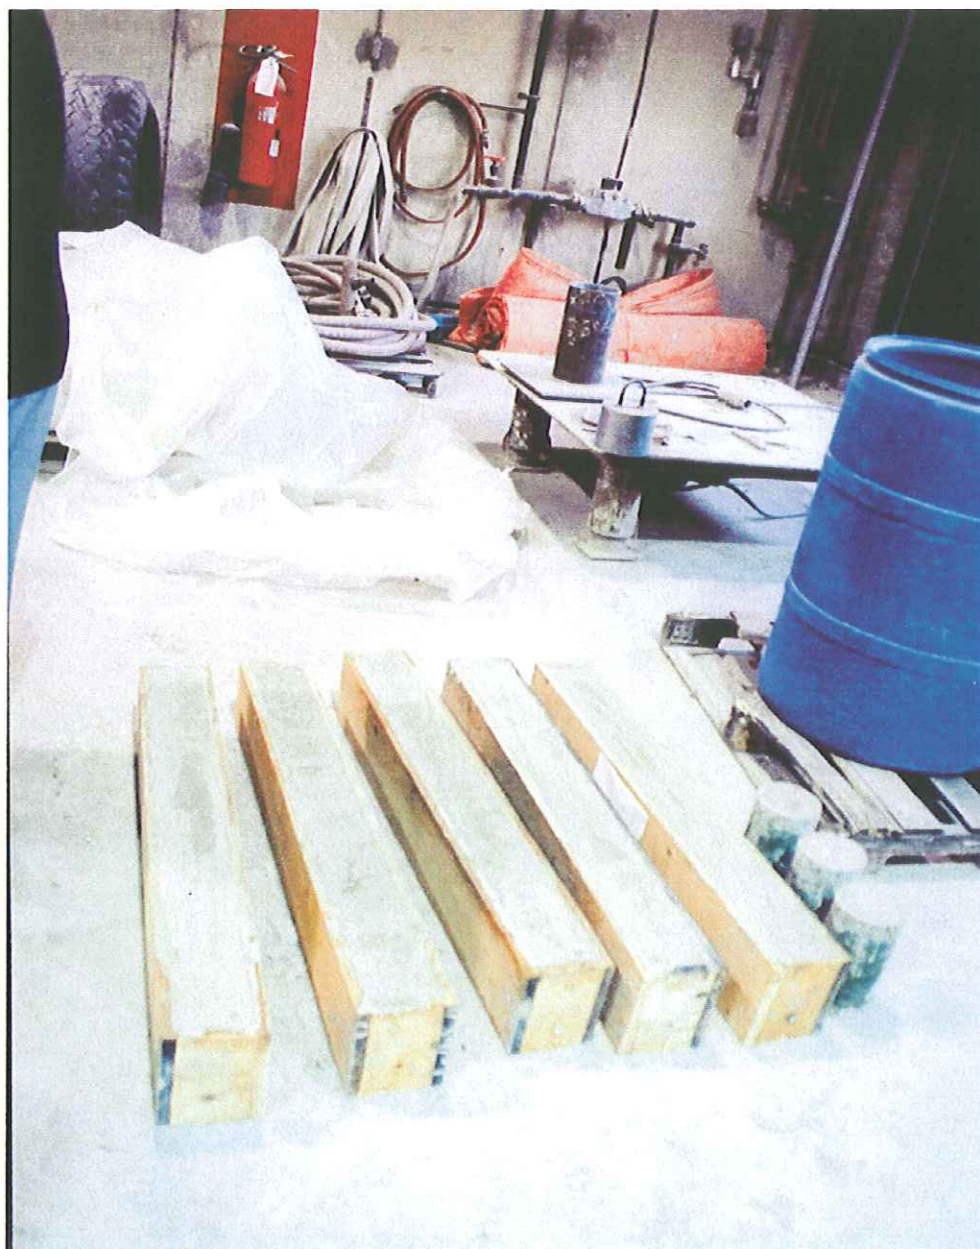
Figure 4.1. Reinforced concrete beams cast in plywood forms.

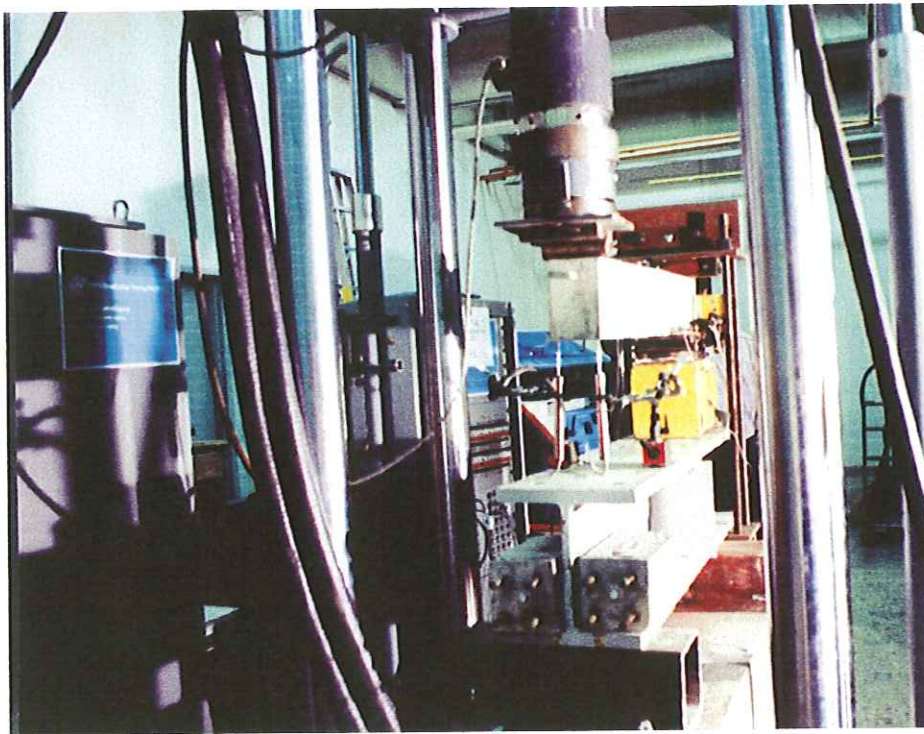
Figure 4.4. Test set-up and location of the instrumentation in the first trial.

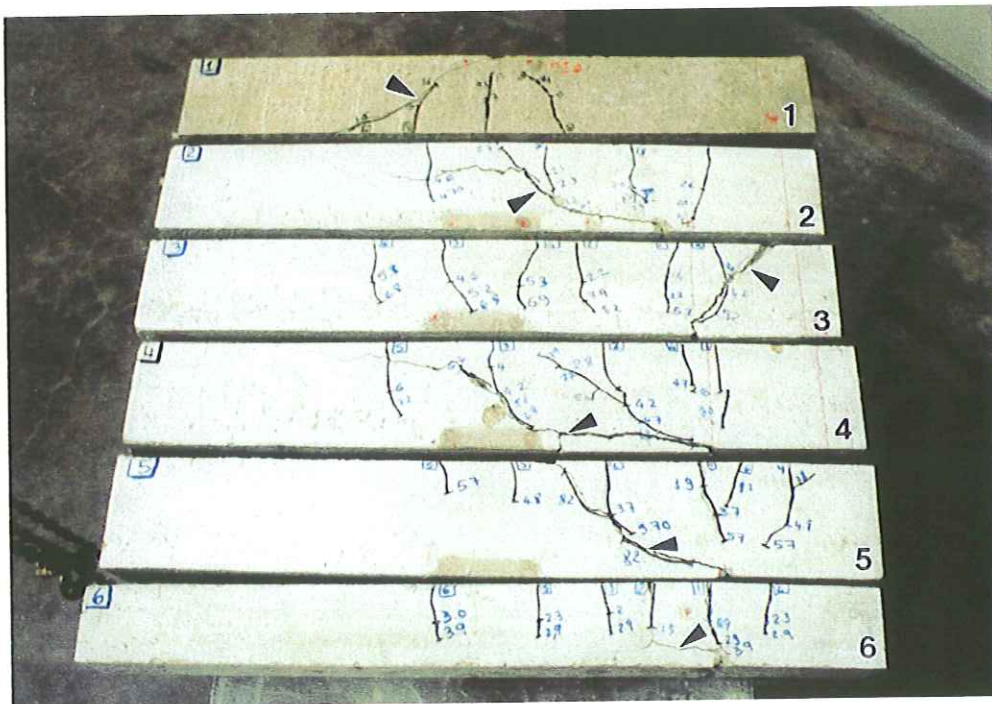
Figure 4.5. Crack pattern and mode of failure in reinforced concrete beams tested (trial 1).

The crack patterns at failure of the reinforced concrete beams tested in the first trial are shown in Figure 4.6. Initial cracking occurred at a load that ranged between 1.6 kN and 2 kN. Cracking consists predominantly of flexural cracks (vertical cracks). The stabilization load of flexural cracks ranged between 3 kN and 6 kN. As loading progressed, the flexural cracks bent over in the shear regions. However, only one crack led to failure as shown in Figure 4.5.

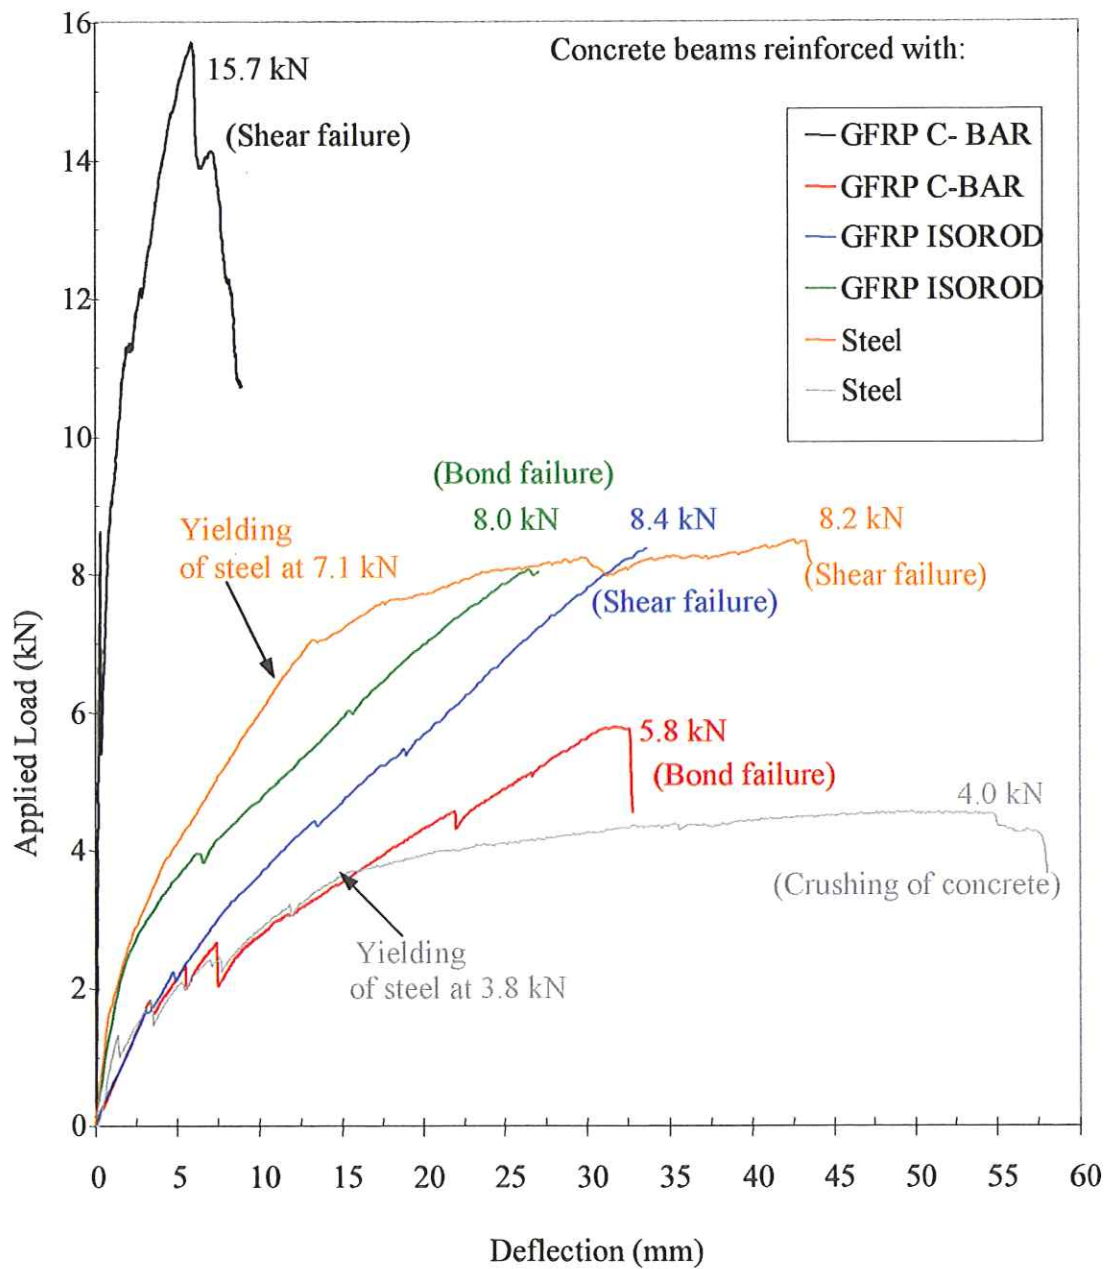
Figure 4.8. Load–deflection behavior of the reinforced concrete beam tested in the first trial.

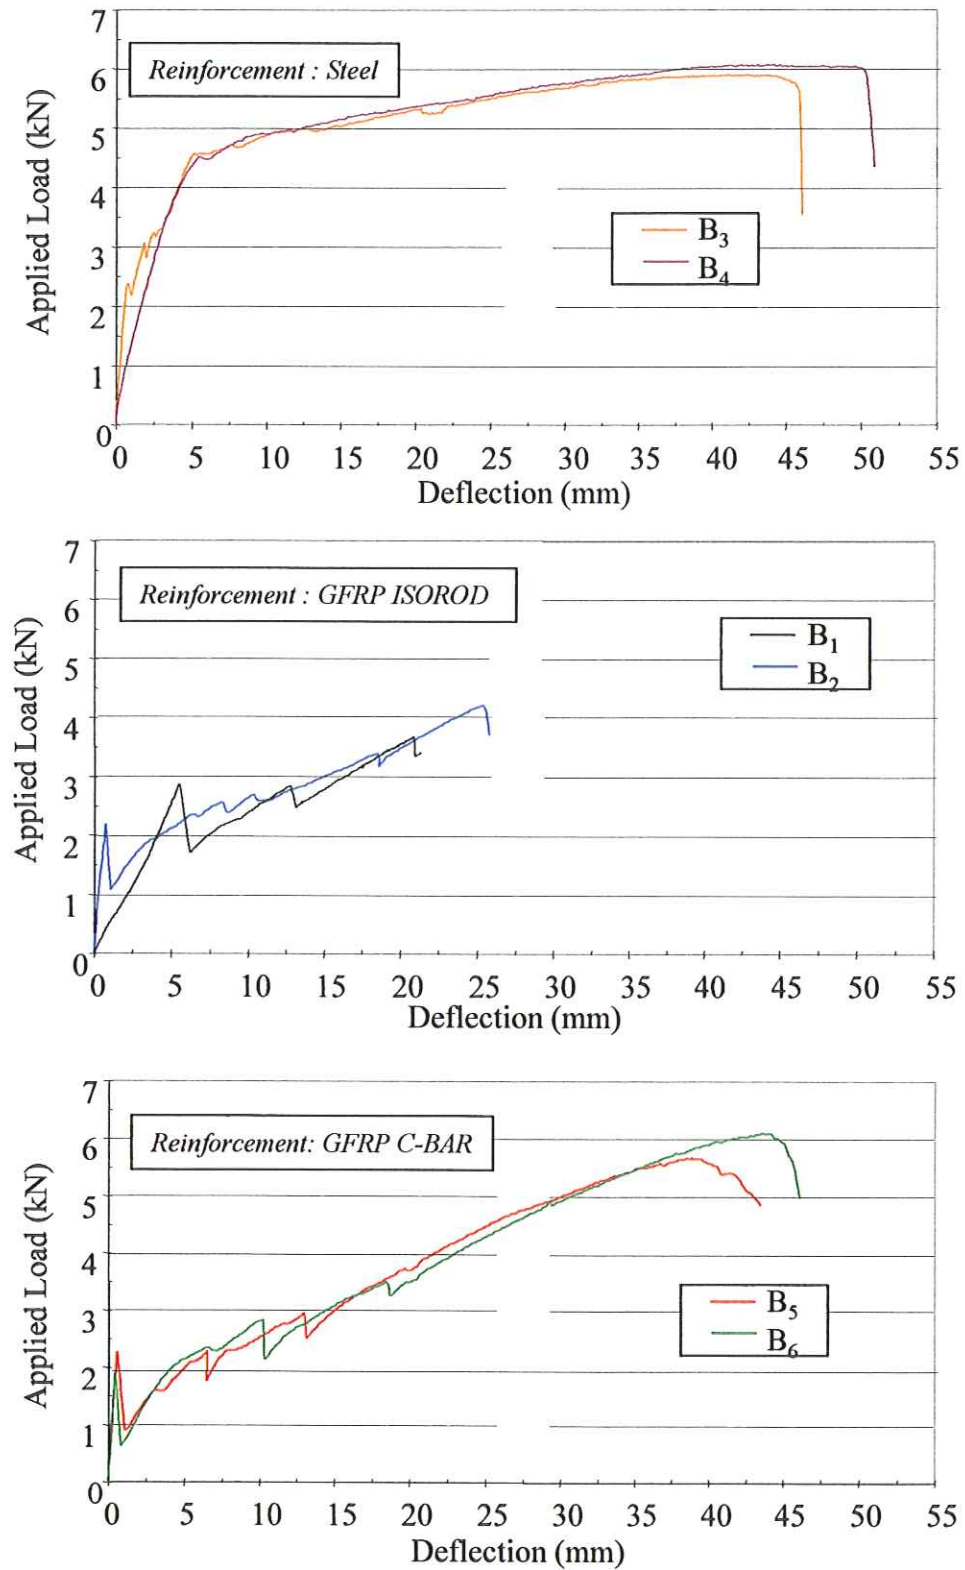
Figure 4.9. Load–deflection behavior of the reinforced concrete beam tested in second trial.

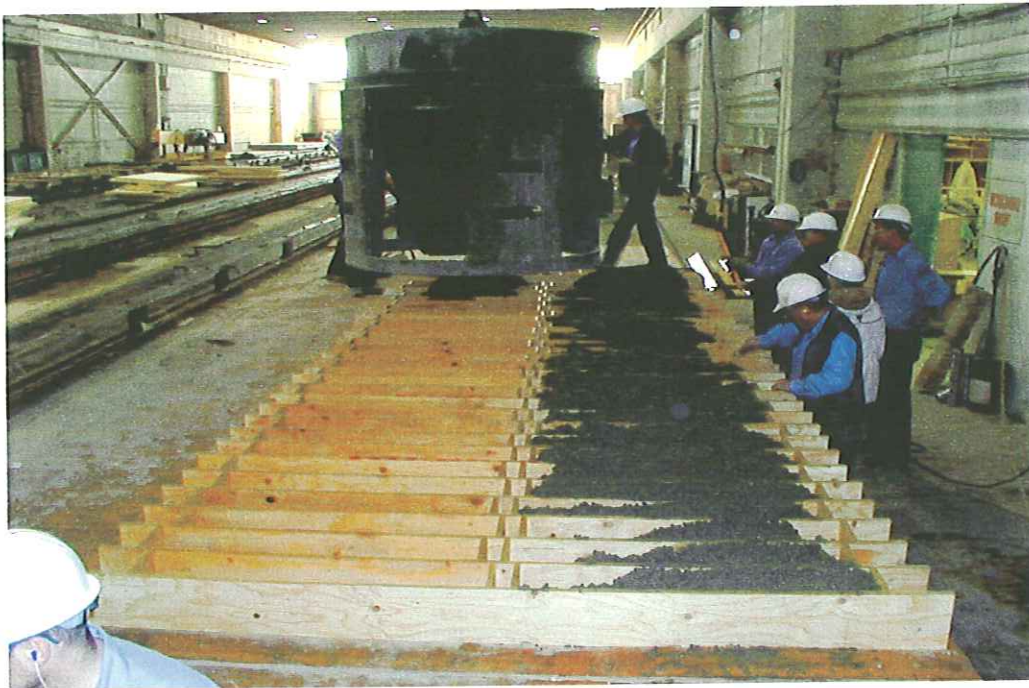
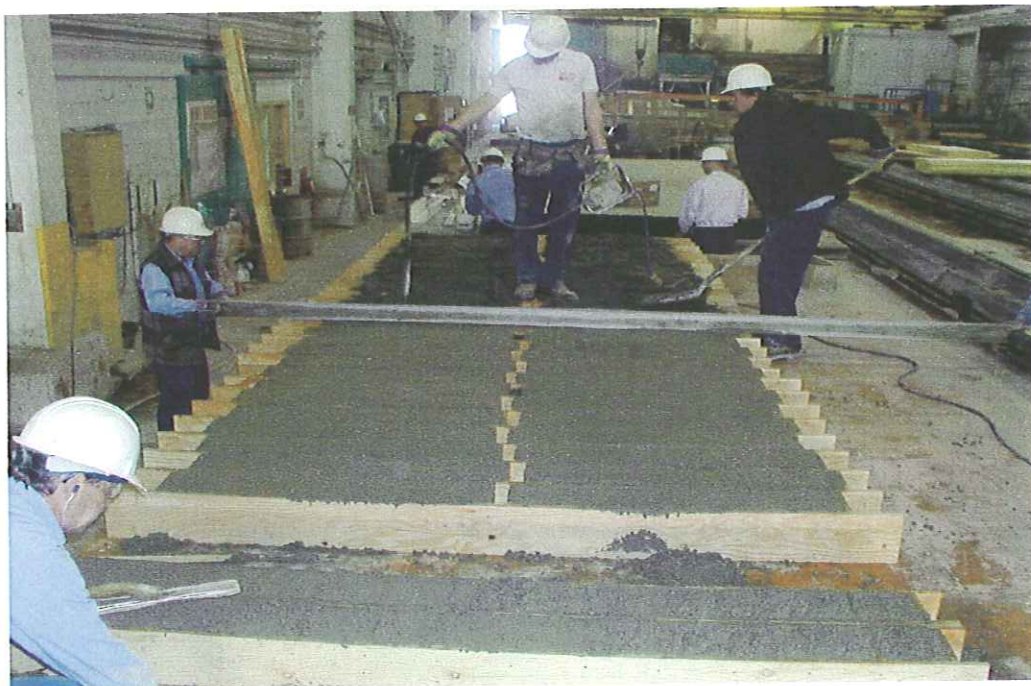
Figure 6.1. Casting the reinforced concrete beams for A, B, and C series

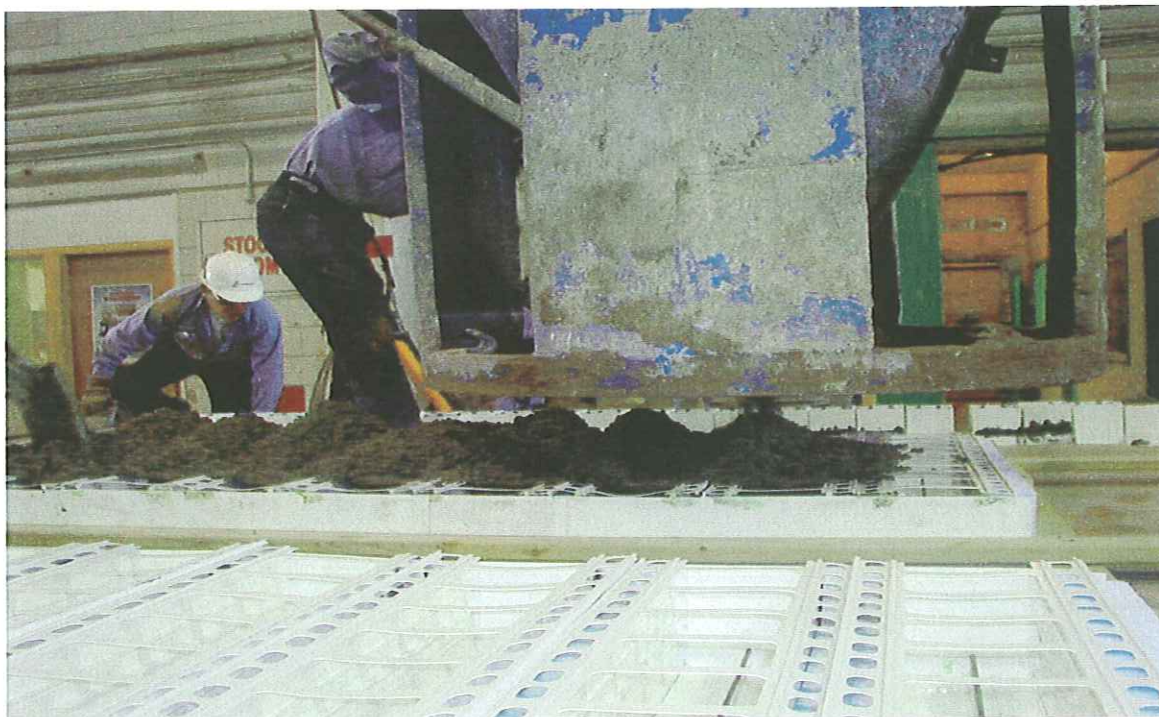
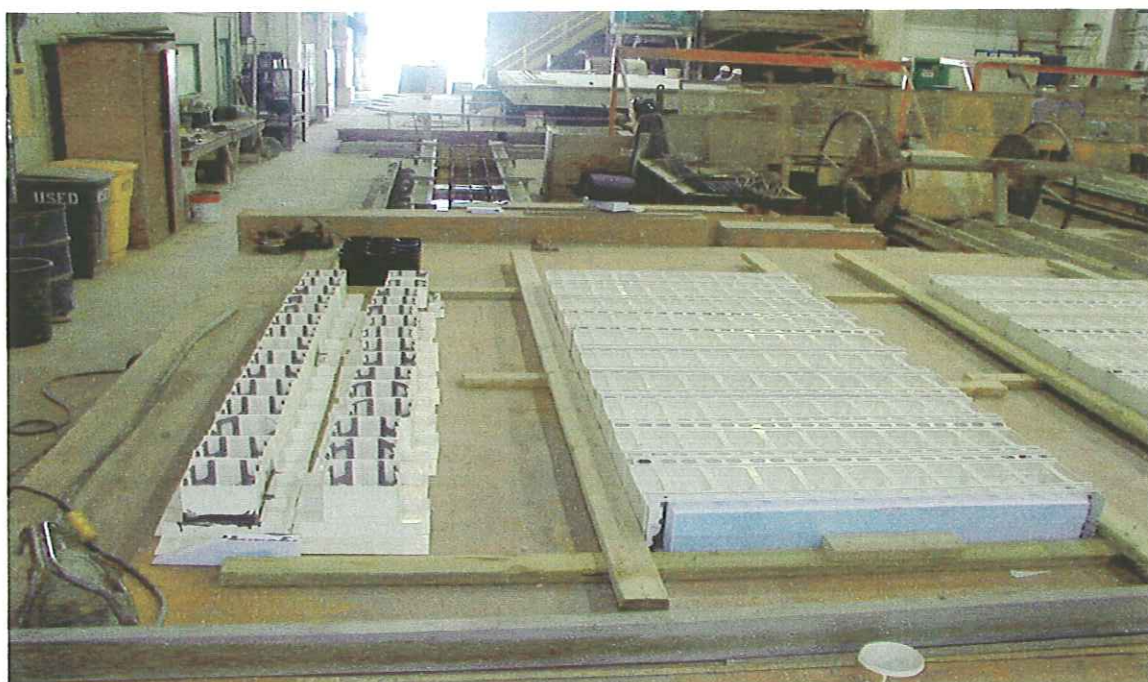
Figure 6.2. Casting the reinforced concrete beams covered with PVC, D series.

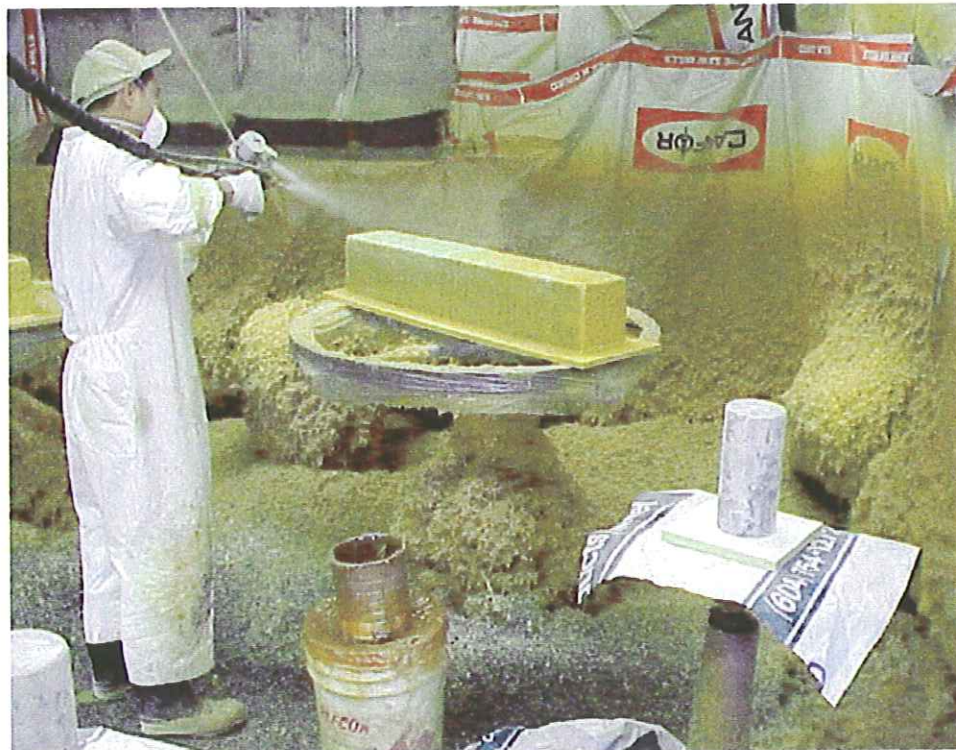
Figure 6.3. Reinforced concrete beams sprayed with GFRP composite.

A set of 20 reinforced concrete beams have been sprayed with GFRP composite (Figure 6.3). The composite consists of short, randomly distributed E-glass fibers embedded in a polyester matrix. The GFRP composite is sprayed on the surface of the concrete at a high speed and compacted pneumatically on the application surface. The sprayed concrete specimens have been used to assess the protective capabilities of sprayed GFRP with time under hog manure environmental conditions.

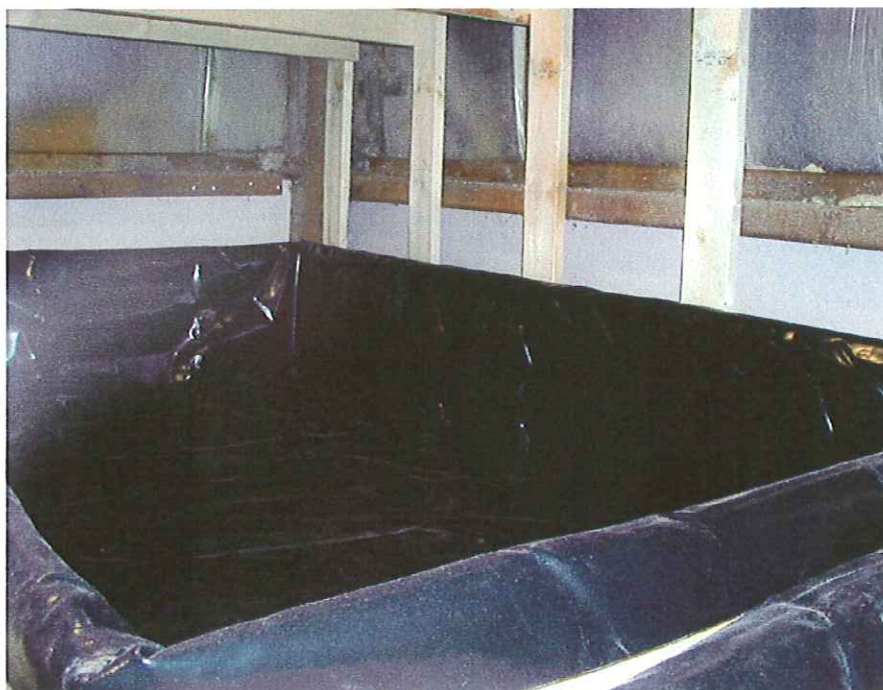
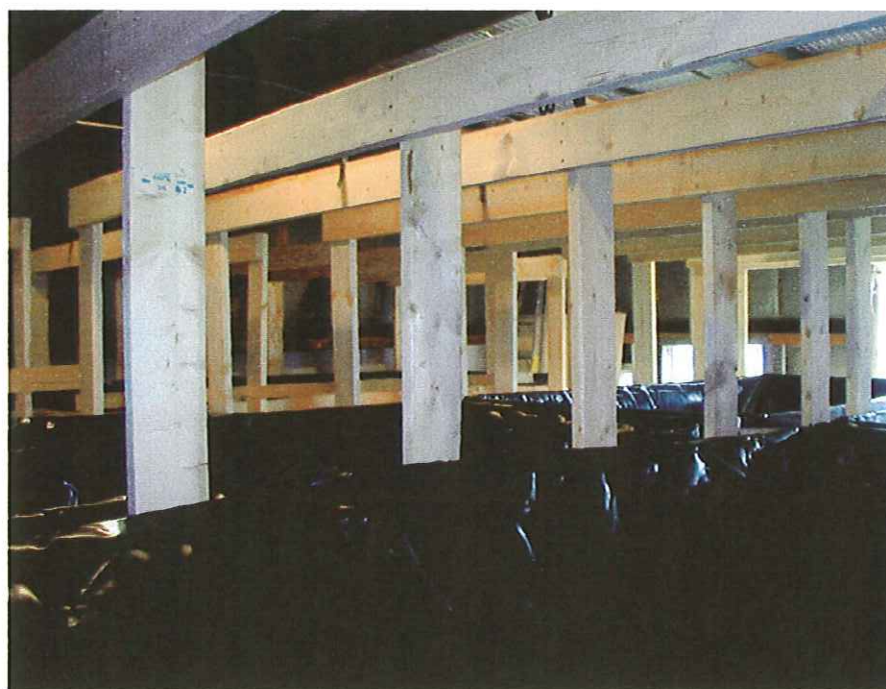
Figure 6.4. Containment units lined with heavy-duty plastic liner

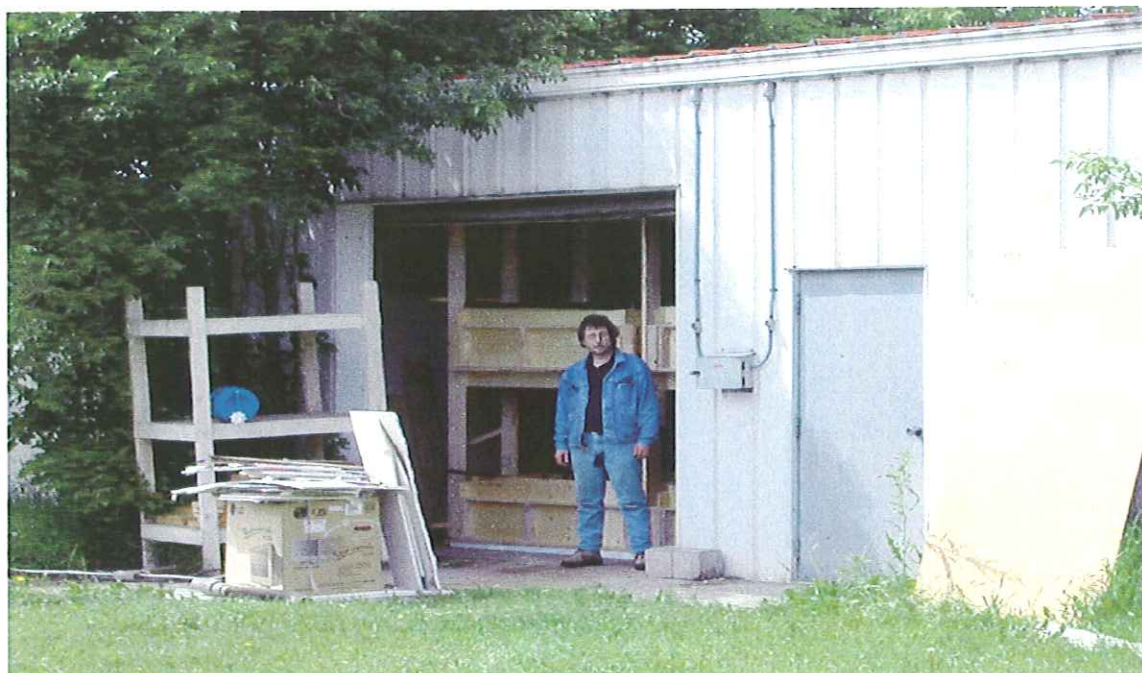
Figure 6.5. The experimental site at Glenlea Research Station Manitoba.

The large scale experimental tests included in the program have been carried out at the experimental site established at Glenlea Research Station Manitoba in a restored barn (Figure 6.5).

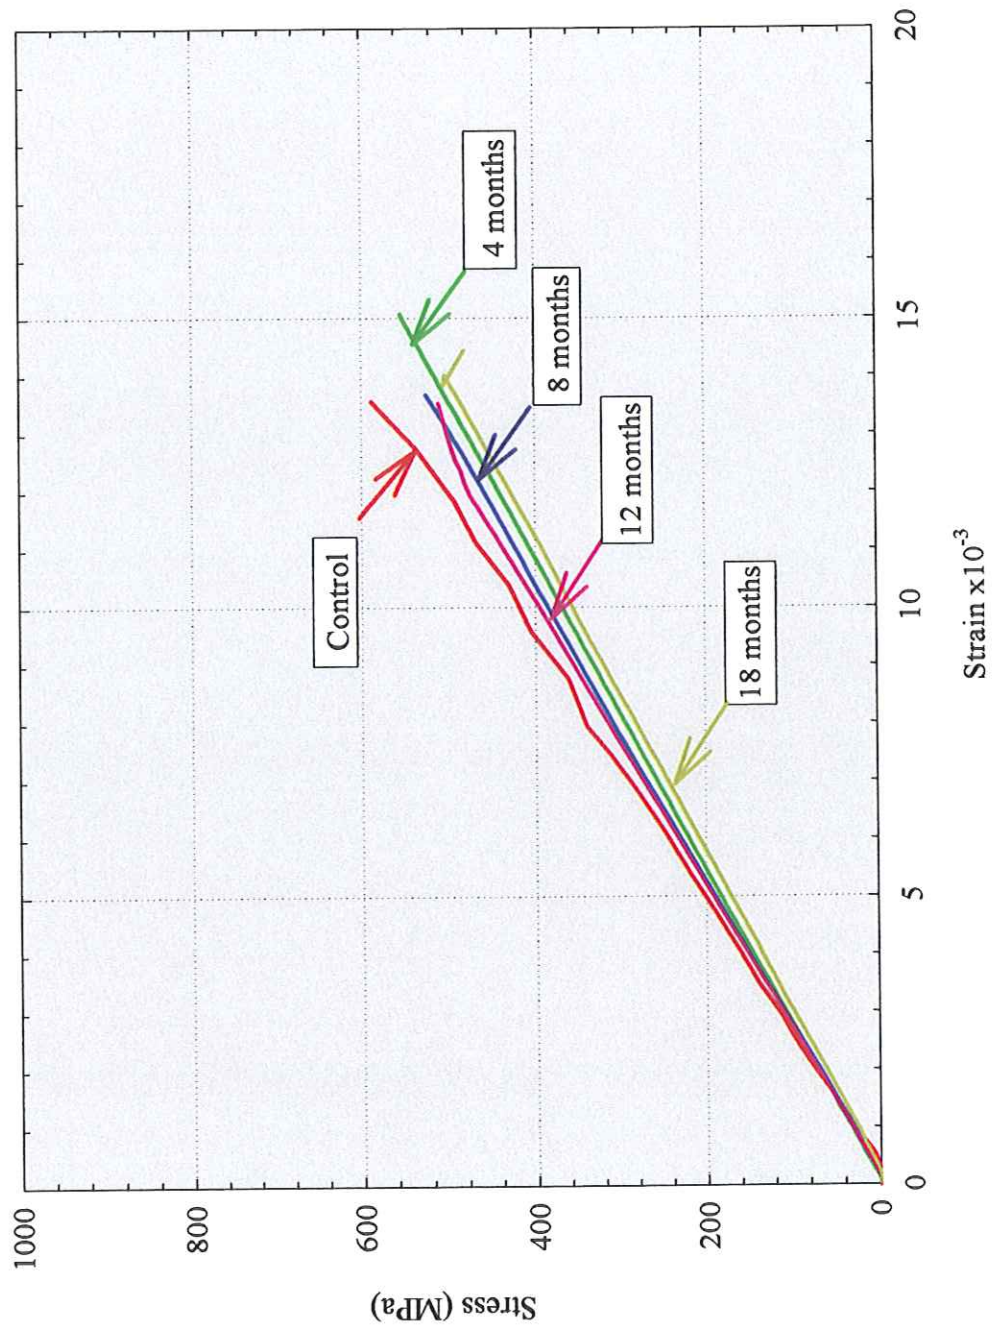
Figure 7.4. The effect of exposure time on the stress-strain behavior of reinforced ISOROD bars.

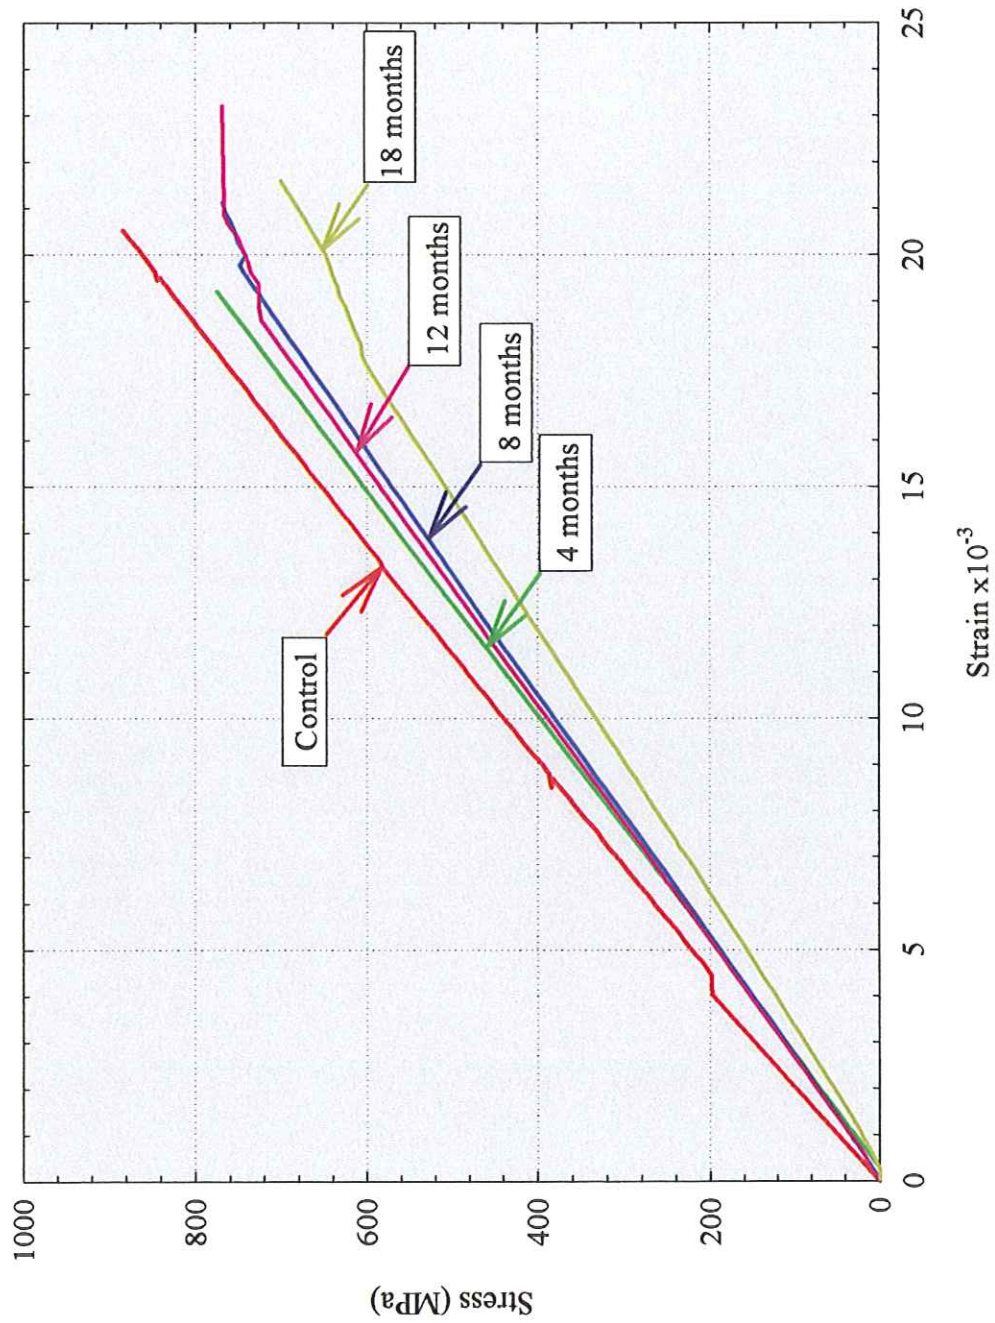
Figure 7.5 The effect of exposure time on the stress-strain behavior of GFRP C-BAR bars.

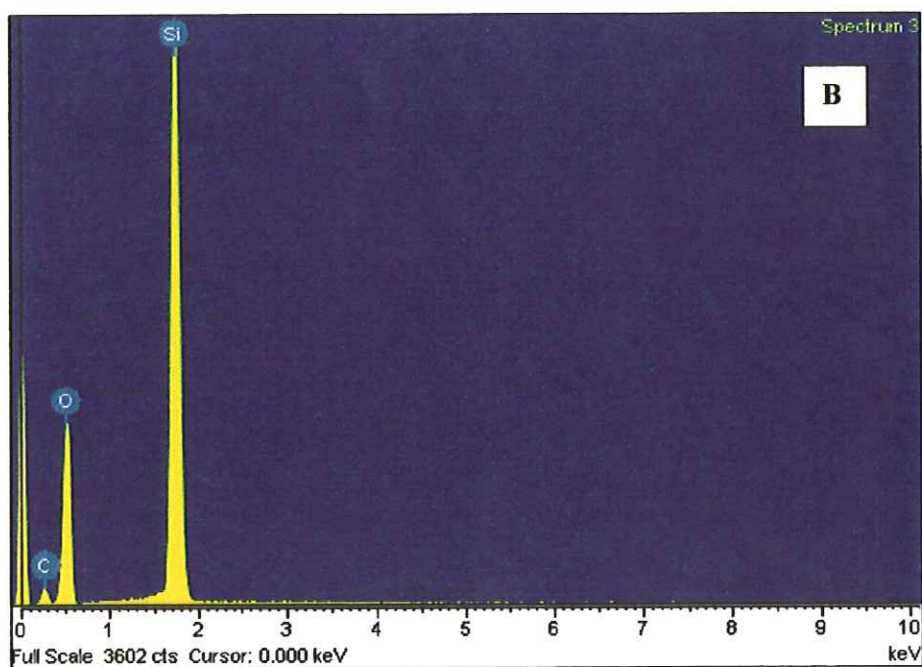
Figure 7.7 Scanning electron microscope micrograph of: A) cross section of the ISOROD bar after 12 months exposure to manure environment and B) chemical composition of sand grain.

Microscopic examination carried out to evaluate the morphological changes and the degree of degradation due to interaction with the manure environment on the randomly selected specimens exposed for 12 and 18 months revealed no visible changes in the specimens exposed for 12 months (Figures 7.7 and Figure 7.8). The photomicrograph of the cross section of selected GFRP - ISOROD bar and C-BAR specimens after 12 months exposure shows that the thermosetting polymer resin that binds and covers the glass-fiber strands is intact and well bonded to the glass-fiber strands. No degradation (i.e., formation of gel-like material, swelling, dissolution or blisters) of the outer surface of the bars containing polymer resin was observed. However, microscopic examination of selected specimens revealed the presence of manufacture imperfections such as polymer resin discontinuities and large amounts of debris of different sizes embedded in the outer-polymer layer as well as between glass-fiber strands. Similar features were observed in the control specimens. The debris was found to consist of the same elements that are present in the glass fiber strands (i.e., Al, Ca and Si), however in different concentration (Figure 7.8B). The debris is richer in Al and deficient in Ca. Examination of the 18 months-exposed specimens suggests some GFRP degradation only on the GFRP C-BAR bar specimens. However, the degradation area was confined only to the lugs (protrusions) which are to prevent longitudinal movement of the bars relative to the concrete surrounding the bar. This may be related to the imperfections / physical damage of the coating polymer in this area during handling. It should be noted that the imperfections / damage were not due to chemical degradation. However, they could provide a pathway for the ingress of moisture and chemicals present in manure into the C-BAR composite, leading to the initiation of degradation of the fiber-matrix interface and the fibers in these areas (Figure 7.9).

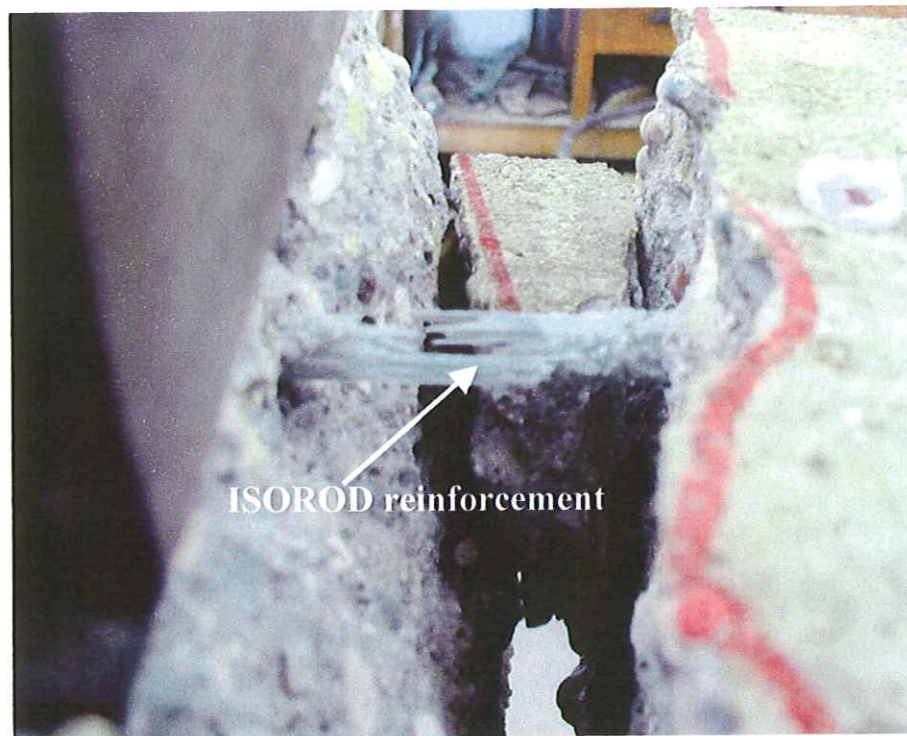
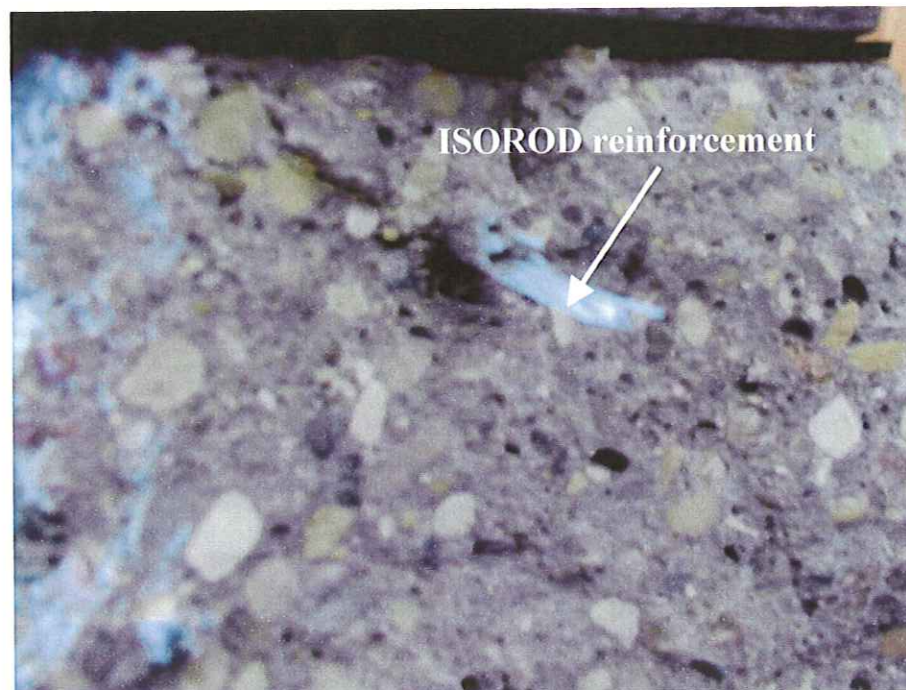
Figure 7.17. Typical failure pattern of the ISOROD reinforcement bar in concrete beams.

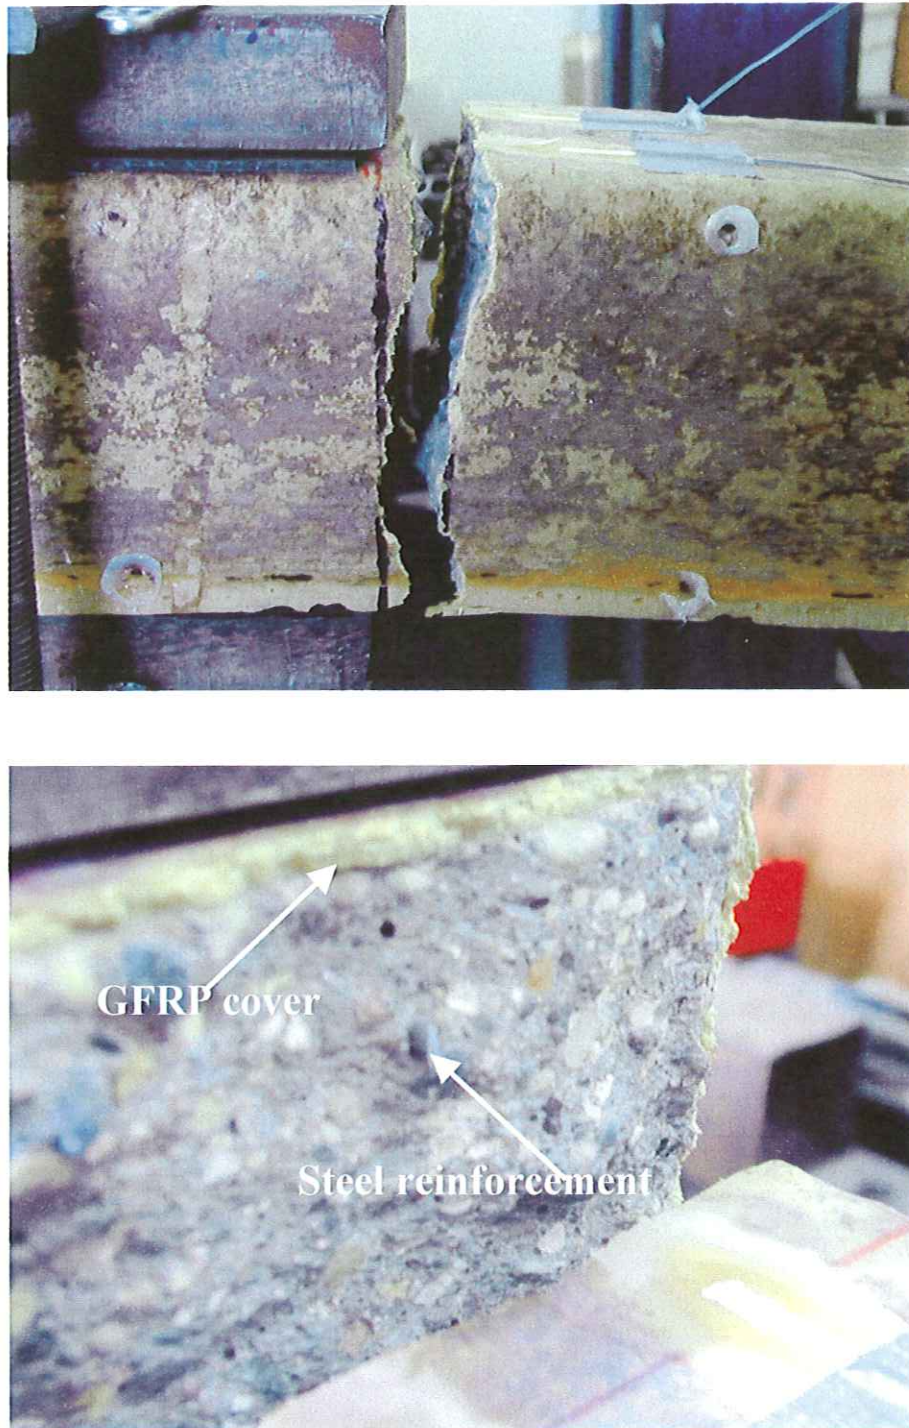
Figure 7.19. Typical flexural failure of the concrete beams reinforced with steel and sprayed with GFRP after 18 months exposure to manure environment.
