Seismic Testing of RC Concrete Squat Wall with Opening w/o Octaform system Vancouver, BC

Prepared for: Octaform Concrete Forming Systems Vancouver, BC

Prepared By:
Jose Centeno
Devin Sauer
Felix Yao, P. Eng
Dr. Carlos E. Ventura, P.Eng

> July 2007 EERF 07-07

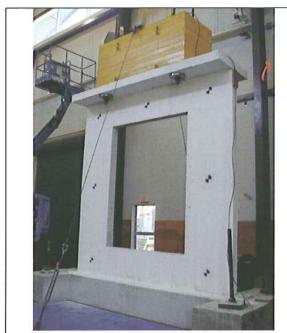
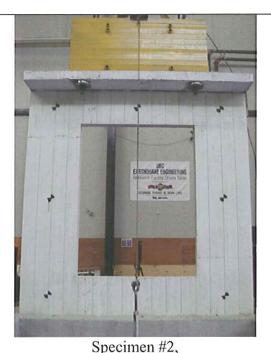
Figure 2 — Test Specimens before Testing

The test specimen foundation was bolted with high strength threaded steel rods to the EERF shake table frame to achieve a rigid connection. Shims were used in areas in which the base of the specimen foundation was uneven with respect to the table and a surcharge weight of 44.6kN was bolted to the slab of the specimen. Figure 2 shows images of both test specimens with test setup.

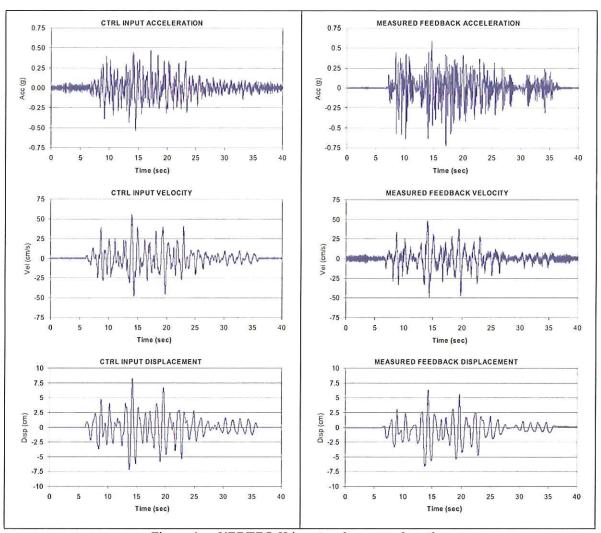
Figure 4 — VERTEQ II input and measured motion

In Figure 4, the VERTEQ-II 100% input waveform's acceleration, velocity and displacement time histories are plotted against the respective measured values generated by the shake table during testing.

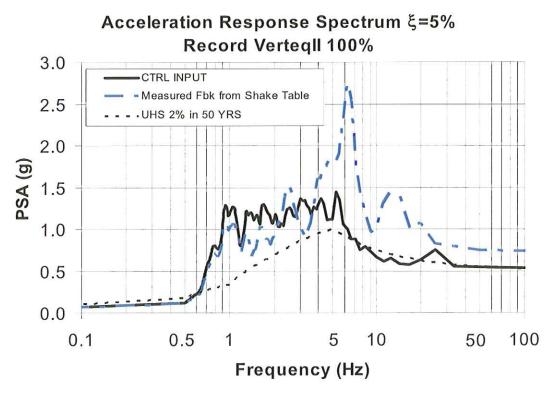
Figure 5 — Response Spectrum

Figure 5 below shows the acceleration response spectrum, which is plotted for the VERTEQII 100% input and measured acceleration records, as well as the UHS 2% in 50 years for Vancouver.

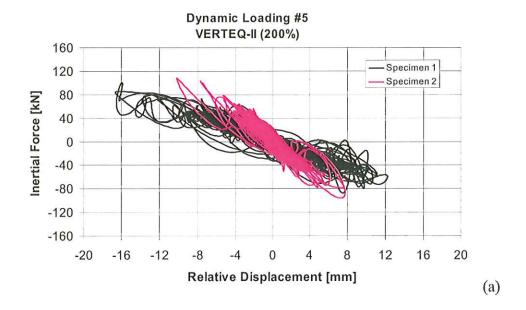
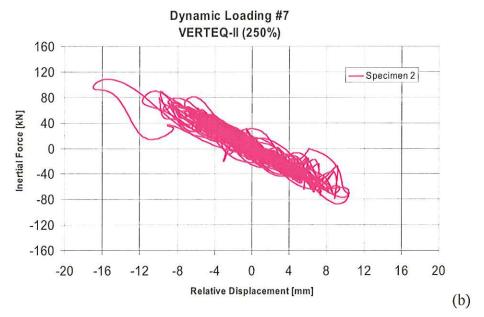
Figure 14 —Inertial Force vs. Displacement for

Figure 14a shows the variation of the inertial force versus the displacement for both specimens during the fifth dynamic loading, VERTEQII 200%. The load deformation plot for specimen 2 shows a higher stiffness than specimen 1, which relates to the difference in cracking observed for both specimens at this stage of testing. After increasing the dynamic load to VERTEQII 250%, the load deformation plot for specimen 2 showed a similar stiffness to specimen 1 at VERTEQII 200% (see Figure 14b). This

suggests that cracks were formed within the cross section of the specimen with the OCFS, but at higher loads. Little energy dissipation was observed for both specimens.

- a) dynamic Load #5 VERTEQII 200%
- b) dynamic Load #7 VERTEQII 250%
